Phoenix

Issue 2 – August 2009

The Newsletter of the Great Melbourne Telescope Project

REMOVAL OF HOUR ANGLE DRIVE GEAR FROM NORTHERN CONE

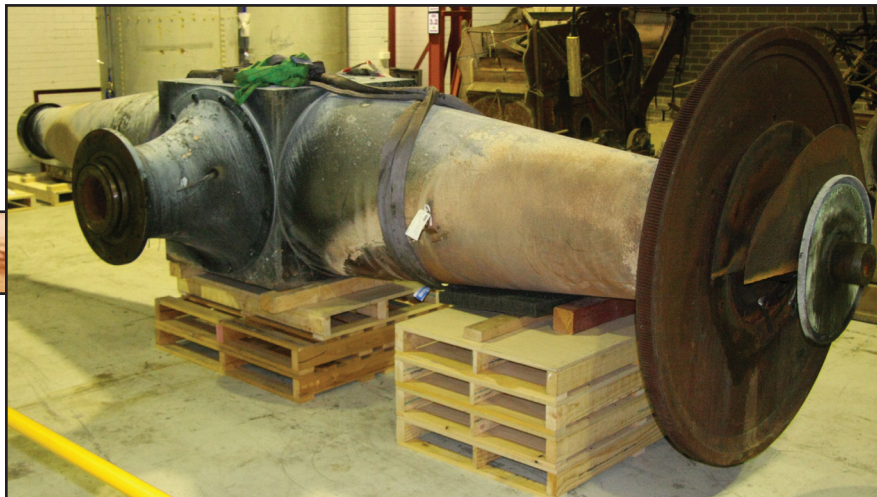
Here's the assembled two-cone polar axis assembly, with the declination axis running through the cube. The right-hand cone is termed the "Northern Cone" because it pointed at the North Celestial Pole (down through the Earth) when the telescope was in its working location. Prominent at its end is a 60-inch (1500 mm) solid iron worm wheel with 480 teeth around its circumference - about 5 teeth every 2 inches. For operation at Mt Stromlo, this disk was driven by a worm gear to turn the entire assembly, with telescope attached, about the polar axis - that is, altering its Hour Angle (so as to keep the telescope pointing at a given Right Ascension). In the original instrument, the moving parts weighed over 8 tons.

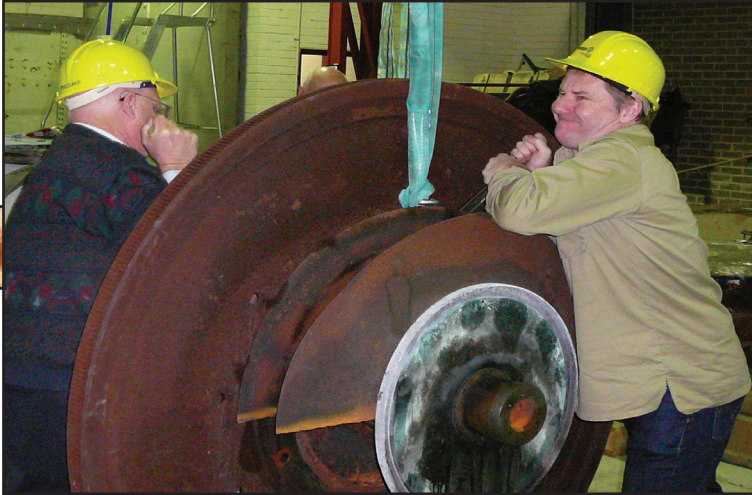
Picture 1 shows more detail of the HA drive gear and a smaller, corroded brass or bronze toothed wheel nearer the end of the shaft. In between them is half of a reel with electrical cables (the other half having been sawn off and discarded at Mt Stromlo). This reel had to be cut further with a sabre saw to allow its removal before anything else could be freed. **Picture 2** shows the cable reel now detached, with some of the badly-burnt copper cables trailing out of it.

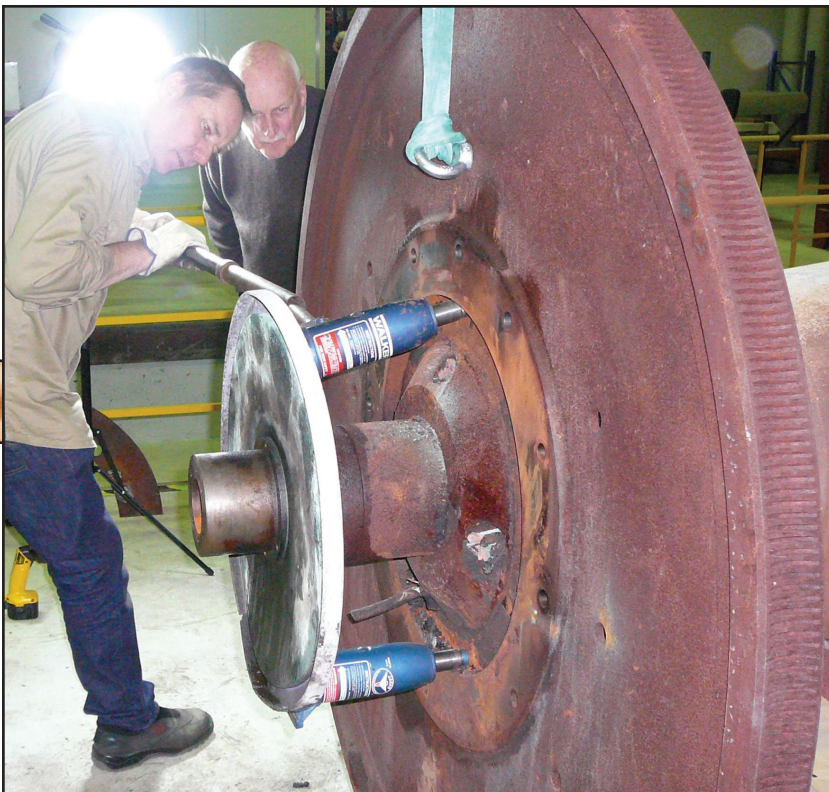
Picture 3

This small toothed wheel was probably added at Mt Stromlo, for sensing the telescope's position in Hour Angle. It appeared to be attached to the shaft by a retaining ring fixed to the hub by six socket-headed screws, one of which was found broken. The remaining screws were removed, with difficulty, but this did not release the toothed wheel or its ribbed protective housing. We then realised that the wheel was an

interference fit onto the hub, and there was no way to get purchase to pull it off, short of building a 20-inch cog puller or hiring the only one known to be available, which was hours away in Mornington.

However, we were able to get a hydraulic (bottle type) car jack between the hub of the 60-inch HA drive gear and the wheel. The jack was nearly horizontal, which led to problems with its internal oil pump needing to be primed. By pressing on the housing with the jack, we were able to distort it to press against the toothed wheel, but the wheel distorted instead of moving. MV then provided three 8-tonne truck jacks, and by pressing at two or three points (**picture 3**) we were soon able to crack a gap. Repetition of the technique at points all around it eventually moved the wheel and its cover off the shaft completely.

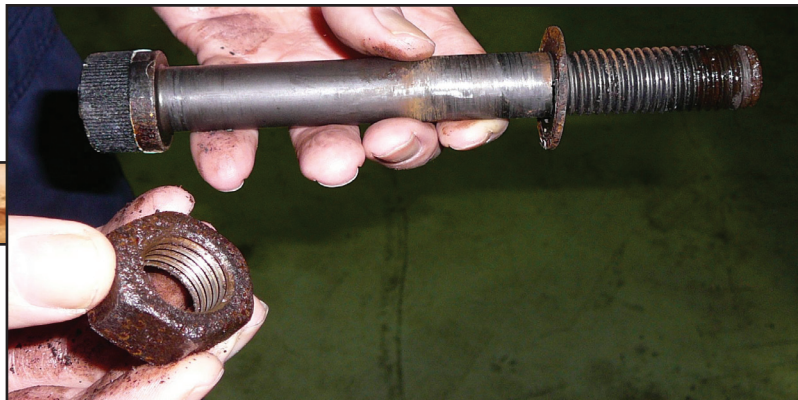
Picture 4

This is a 1950s Stromlo nut and bolt; but we later found that earlier Imperial threads were in similar good condition, which raised our hopes that all the bolts might come out easily, once started, even when the bolts, nuts and surrounding metal were rusty. All bolts had been done up very tightly, and of course that was under *sliding* friction until the rotation stopped; to undo them meant overcoming *static* friction, which is greater. We grew to relish the sound of the “crack” as a nut or bolt suddenly began to rotate under our ministrations. That, and the smell of WD-40 in the morning ...

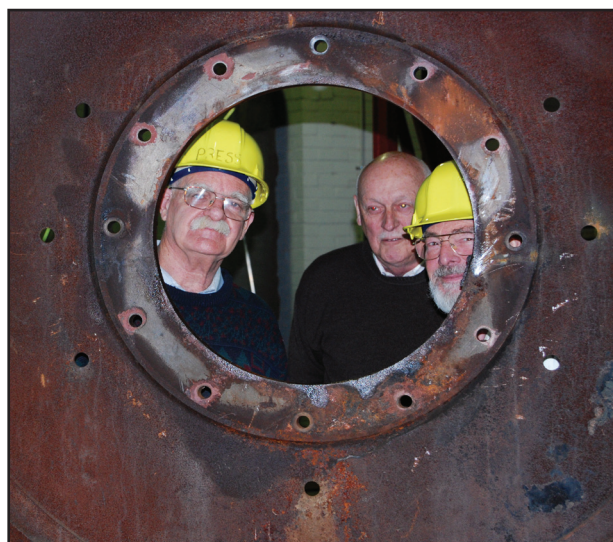
Picture 5

The northern cone is not an original part, but was added by Mt Stromlo engineers in the 1950s to allow the telescope to continue observing an object for longer after its meridian passage. A careful study of their engineering drawings revealed that the cone's function was to fit into a circular recess on the face of the cube and present an identical recess at the cone's other end for the original northern hub of the polar axis to fit into. The recess presents a face about 35 mm deep around a 570 mm circle, in which the hub for the Hour Angle gear fits. We feared that the mating surfaces may have been rusted together, but they turned out to be in good condition, with only a slight colouring of rust; only friction and accurate Stromloidal engineering were holding them together.

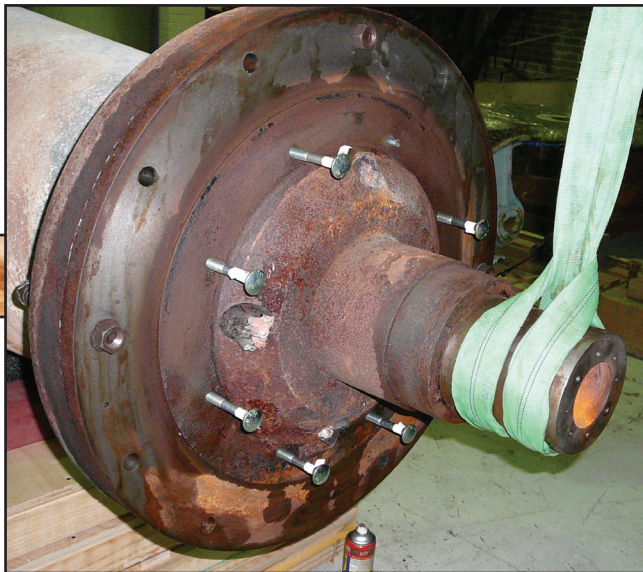
Picture 6

However, the hub would not budge off the end of the cone, despite some judicious tapping and levering. The solution came to one of us while lying half-awake at 4:30 one morning: the hub had a circular array of eight threaded holes about halfway out from its centre. These had not been used for a long time, and would have been part of Grubb's original 1868 configuration. Long enough bolts screwed into these holes should pass right through and press on the inner surface - the end of the cone - thus pushing the hub away from it.

We determined that these holes had been tapped with a 1/2" Whitworth thread, so someone was sent to a nearby hardware store to buy eight long bolts with 1/2" threads. The only stocked bolts long enough were coach bolts, but they would do. Meanwhile, we had carefully cleaned up the threads in the holes, and on screwing in the oiled coach bolts, at the right depth we felt them press against the inner surface. **Picture 6** shows the situation at that stage; note the three capturing bolts in the outer circle, and the taut crane sling, each able to take the weight if a sudden separation occurred. We then continued to turn the coach bolts by half-turns, using about 100 Nm of force on each of them in a staggered order, using a long-handled socket driver. Imagine our elation as a small gap appeared and the hub began to slide out of the end face of the cone. However, we were not able to lever it out - we had to push it all the way using the coach bolts.

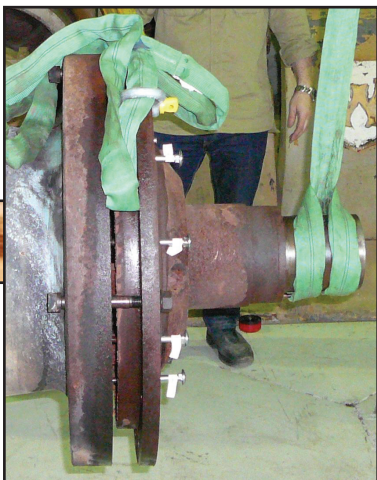
Picture 7

With the hub completely detached but retained by the three outer bolts (**picture 7**) and stable, we attached crane slings to holes in its upper part, removed the three bolts and began to pull it out by sending the gantry crane East (**picture 8**).

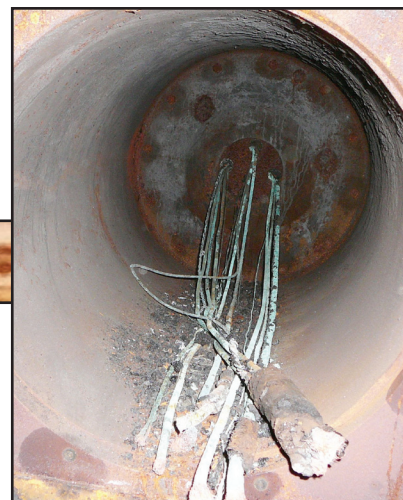
Picture 9

The hub had four steel pipes which served as conduits for electrical cables, running inside the northern cone along its full length; these once fitted, with a rubber lining, into the back of the hub and into the face of the cube, but now they were firmly stuck to the hub by burnt rubber. The pipes therefore pulled out from the cube instead of the hub, but the cables stayed attached to the cube and, with their burnt insulation, they exerted a significant friction as the pipes slid along them. Anyway, with the hub and pipes gone, for the first time we could see clearly into the cone; **picture 9** shows the inside of the "cube end" of the cone, with four bunches of burnt cables coming out of it. Note especially the 12 rusty bolt heads around the edge of this end face. These attach the cone to the cube; and undoing them will be a story for *Phoenix* issue #3.
